**Flood Control Project Maintenance
Levee Inspections**

Fall 2018 Levee Maintenance Deficiency Summary Report

**Flood Control Project Maintenance
Levee Inspections****LMA District Cover Sheet****Fall 2018 Levee Inspection Results****Levee District No. 0001 (Glenn County)**

Levee District No. 0001 (Glenn County)

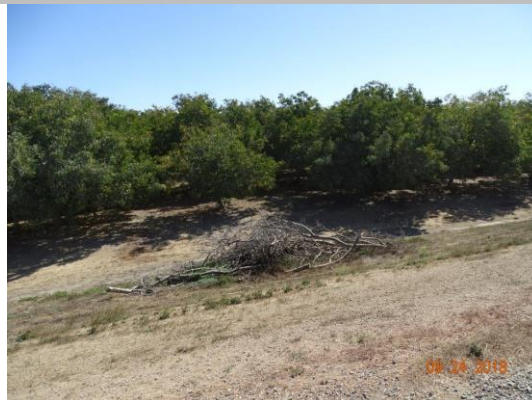
Photo 1 of 1 : FA_2018_LD0001G_432_61_20181105_00114.jpg

LM Start	0.92	Rating **	M	Issue No.	61
LM End	0.92	Issue Type +	En	Location *	WS
Category	Earthen Levee			GPS Latitude/Longitude	
				Start	End
Item	Encroachments			39.489718 °	39.489718 °
				-122.020650 °	-122.020650 °
DWR ID	DWR_LD0001G_01_f_2018_61				
Comment Code					
PR : Prunings					
Inspector Comment					
Remove the pruning from the waterside toe.

View of the prunings along the waterside toe.

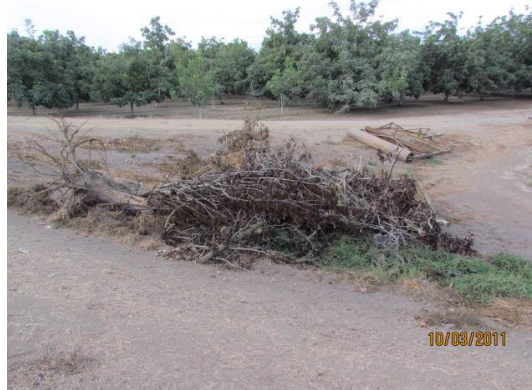
Photo 1 of 1 : FA_2018_LD0001G_432_16_20180905_00007.jpg

LM Start	3.19	Rating **	M	Issue No.	16
LM End	3.19	Issue Type +	En	Location *	LS
Category	Earthen Levee			GPS Latitude/Longitude	
				Start	End
Item	Encroachments			39.514709 °	39.514709 °
				-122.010515 °	-122.010515 °
DWR ID	DWR_LD0001G_01_s_2012_16				
Comment Code					
PR : Prunings					
Inspector Comment

View of the pruning pile along the LS toe.

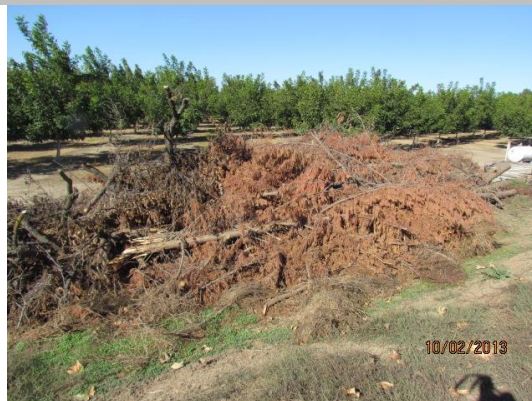
Photo 1 of 1 : FA_2018_LD0001G_432_56_20180905_00018.jpg

LM Start	3.63	Rating **	M	Issue No.	56
LM End	3.63	Issue Type +	En	Location *	LS
Category	Earthen Levee			GPS Latitude/Longitude	
				Start	End
Item	Encroachments			39.520623 °	39.520623 °
				-122.010457 °	-122.010457 °
DWR ID	DWR_LD0001G_01_f_2013_56				
Comment Code					
PR : Prunings					
Inspector Comment

View of the prunings and limbs along the slope of the levee.

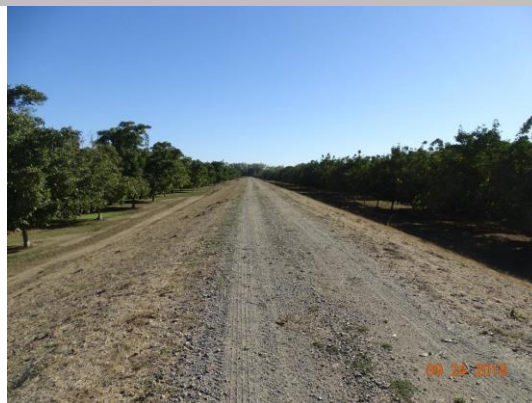
Photo 1 of 1 : FA_2018_LD0001G_432_59_20181105_00110.jpg

LM Start	4.37	Rating **	A	Issue No.	59
LM End	4.37	Issue Type +	Ma	Location *	LS
Category	Earthen Levee			GPS Latitude/Longitude	
				Start	End
Item	Vegetation			39.527792 °	39.527792 °
				-122.003268 °	-122.003268 °
DWR ID	DWR_LD0001G_01_f _ 2018_59				
Comment Code					
V1 : Control annual grass and weeds on the levee slopes and easements.					
Inspector Comment					
The vegetation was removed from both slopes.

View of no vegetation on both slopes.

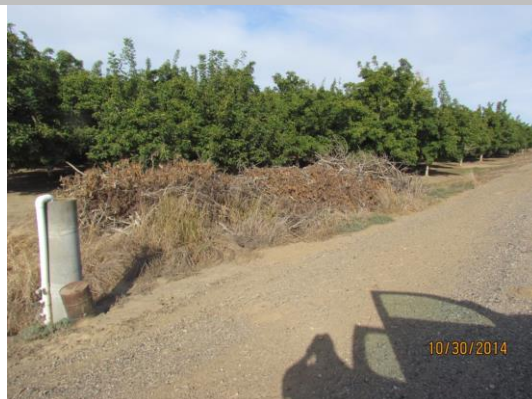
Photo 1 of 1 : FA_2018_LD0001G_432_54_20180905_00017.jpg

LM Start	5.90	Rating **	M	Issue No.	54
LM End	5.90	Issue Type +	En	Location *	LS
Category	Earthen Levee			GPS Latitude/Longitude	
				Start	End
Item	Encroachments			39.545992 °	39.545992 °
				-122.001180 °	-122.001180 °
DWR ID	DWR_LD0001G_01_f_2014_54				
Comment Code					
PR : Prunings					
Inspector Comment

View of the prunings along the landside toe.

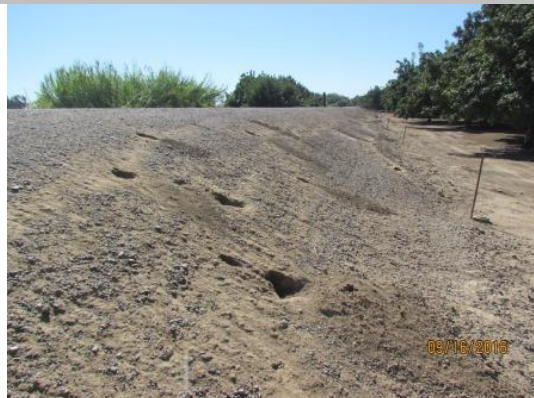
Photo 1 of 1 : FA_2018_LD0001G_432_76_20180905_00030.jpg

LM Start	6.24	Rating **	M	Issue No.	76
LM End	6.24	Issue Type +	Ma	Location *	LS
Category	Earthen Levee			GPS Latitude/Longitude	
				Start	End
Item	Animal Control			39.550725 °	39.550725 °
				-122.002370 °	-122.002370 °
DWR ID	DWR_LD0001G_01_f_2016_76				
Comment Code					
A3 : No rodents visible, but rodent burrows visible; need to backfill and compact or grout burrows.					
Inspector Comment

View of the rodent holes along the landside slope.

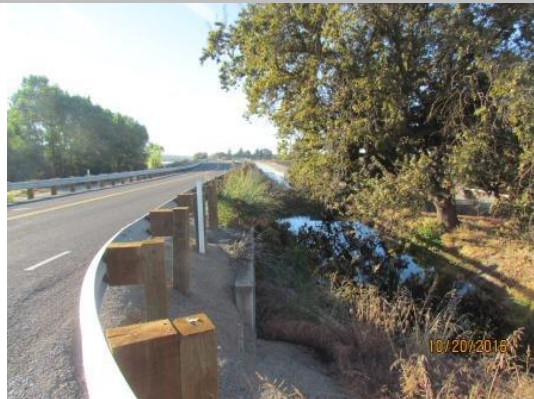
Photo 1 of 2 : FA_2018_LD0001G_432_69_20180905_00024.jpg

LM Start	6.65	Rating **	U	Issue No.	69
LM End	7.75	Issue Type +	En	Location *	LS
Category	Earthen Levee			GPS Latitude/Longitude	
				Start	End
Item	Encroachments			39.556556 °	39.572335 °
				-122.003868 °	-122.004690 °
DWR ID	DWR_LD0001G_01_s_2016_69				
Comment Code					
DT : Ditch					
Inspector Comment					
Concrete lined and earthen ditch/canal at LS toe.

View of the ag ditch looking downstream.

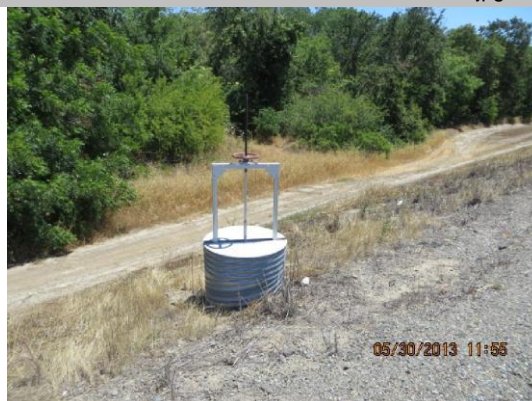
Photo 2 of 3 : UCIP_FA_2018_14384_23663.jpg

Slide gate in 36-inch CMP standpipe on WS slope

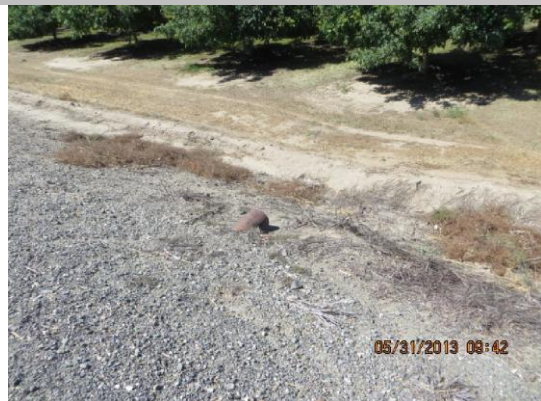
Photo 1 of 3 : UCIP_FA_2018_53341_23668.jpg

Comment Code					
Inspector Comment					
FS_ID:53341 DS_ID:22918 EP_NO: 9563 Repair Type: Non-Urgent Crossing Status: Found UCIP Comments: 10/9/2018 Pipe is open on both ends and damaged on WS. Recommended grouting in place. Crossing downgraded to "Non-Urgent" due to pipe location above floodplain. (O.Yakimov - DWR)12/21/2016 same as last inspection crossing is opened on both ends and damaged on WS slope is visible. According to LMA representative, Nick Henning, pipe appears to be abandoned. (O. Magana - DWR UCIP)05/31/2013 Pipe open on both ends and damaged on WS slope. Pipe should be abandoned properly if appropriate. (W. Wylie - DWR UCIP) FIELD_STRUCT_DESC: *ABANDONED* 12-inch steel drainage pipe through levee, 5 feet below crown. Pipe open on both waterside (WS) and landside (LS) ends. One corrugated metal cutoff wall. (12-inch pipe [HLM 8.6] authorized under Automatic Board Order (ABO) No. 9563, 1974 - County of Glenn). [Additional Reference(s): DWR Levee Log, 1992. USACE Sacramento O&M Manual Unit 140, May 1960, (HLM 8.60)]. FS Date: 10/9/2018 3:57:00 PM

Pipe on LS slope.

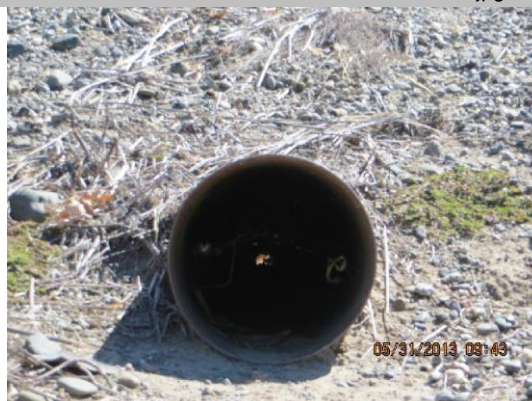
Photo 2 of 3 : UCIP_FA_2018_53341_23667.jpg

Pipe on LS slope.

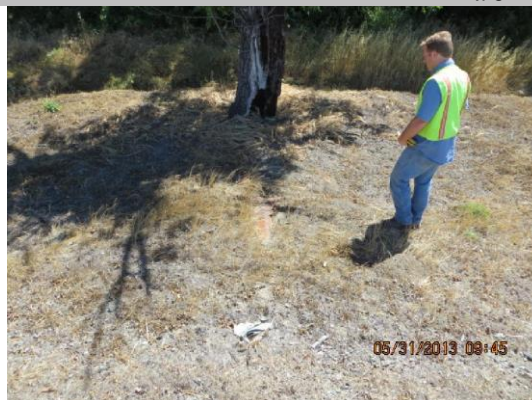
Photo 3 of 3 : UCIP_FA_2018_53341_23666.jpg

Pipe on WS slope.

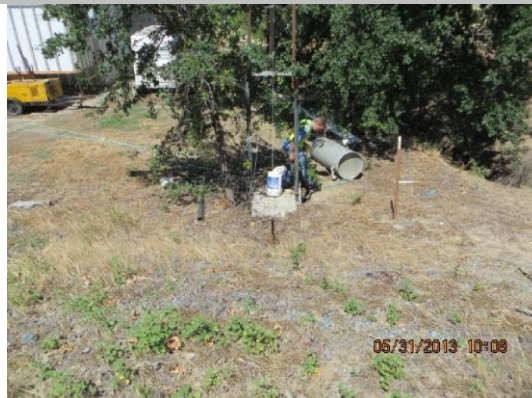
Photo 1 of 3 : UCIP_FA_2018_16204_27330.jpg

Pipe visible next to well with bucket over standpipe.

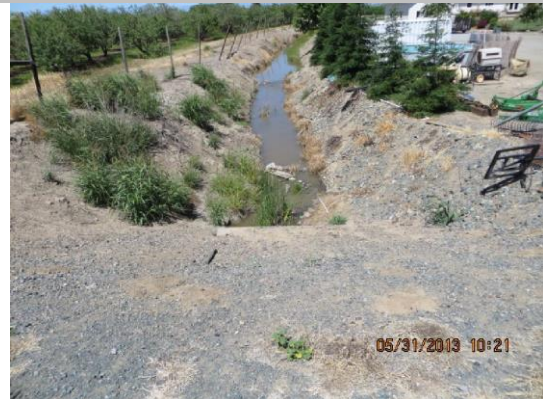
Photo 1 of 3 : UCIP_FA_2018_14389_23686.jpg

Comment Code					
Inspector Comment					
FS_ID:14389 DS_ID:22920 EP_NO: 9560 Repair Type: Non-Urgent Crossing Status: Found UCIP Comments: Heavy rust along springline of pipe. Pipe has slight deformation at centerline of levee, not noticable on crown. FIELD_STRUCT_DESC: 72-inch corrugated metal drainage pipe through the levee, 15 feet below the crown. Flap gate located on the waterside (WS) end. Slide gate in 8-inch corrugated metal riser unit on the WS slope. Concrete headwalls on both ends. Two corrugated metal cutoff walls. (72-inch pipe [HLM 9.64]authorized under Automatic Board Order (ABO) issued as Permit No. 9560, 1974 - John and Lena Friesen). [Additional Reference(s): DWR Levee Log, 1992. USACE Sacramento O&M Manual 140, May 1960, (HLM 9.64)]. FS Date: 5/31/2013

Pipe and headwall at LS toe.

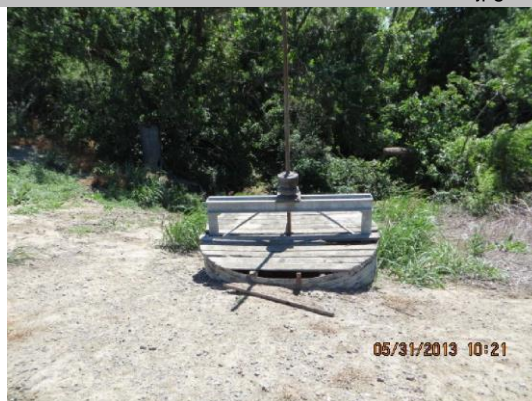
Photo 2 of 3 : UCIP_FA_2018_14389_23685.jpg

Slide gate in 8-foot diameter CMP riser on WS slope.

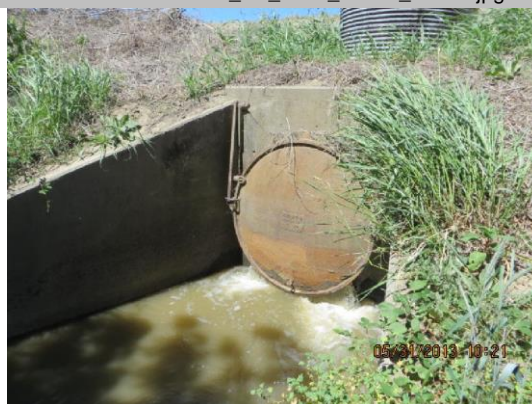
Photo 3 of 3 : UCIP_FA_2018_14389_23684.jpg

Flap gate and headwall on WS toe.

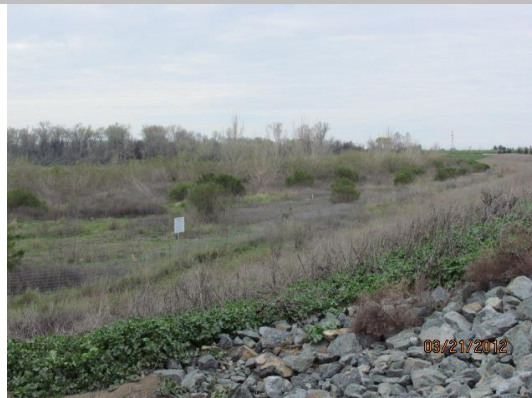
Photo 1 of 1 : FA_2018_LD0001G_432_8_20180905_00004.jpg

LM Start	9.50	Rating **	A/W	Issue No.	8
LM End	10.40	Issue Type +	Ma	Location *	WS
Category	Earthen Levee			GPS Latitude/Longitude	
				Start	End
Item	Vegetation			39.596192 °	39.607288 °
				-122.002573 °	-121.994565 °
DWR ID	DWR_LD0001G_01_s_2012_8				
Comment Code					
V8 : Environmental Requirements.					
Inspector Comment

View of the Army Corps of Engineers mitigation site.

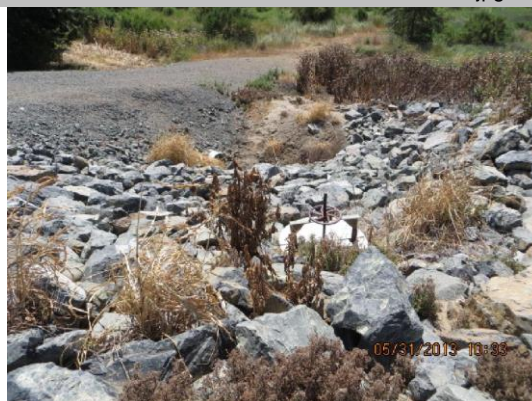
Photo 1 of 3 : UCIP_FA_2018_14390_23690.jpg

Slide gate in 36-inch CMP riser on WS slope.

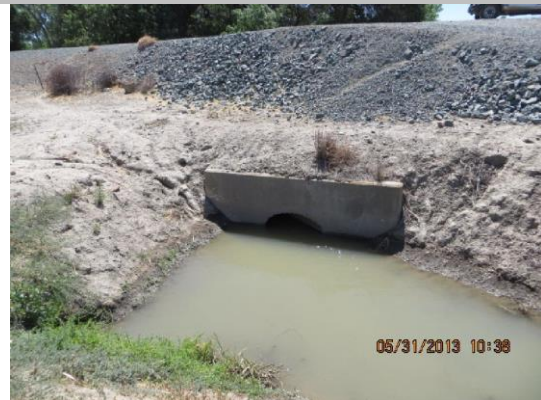
Photo 1 of 3 : UCIP_FA_2018_14559_23986.jpg

Comment Code						
Inspector Comment						
FS_ID:14559 DS_ID:22922 EP_NO: 9558 Repair Type: No Action Needed Crossing Status: Found UCIP Comments: FIELD_STRUCT_DESC: 24-inch corrugated metal drainage pipe through the levee, 11 feet below the crown. Flap gate located on the waterside (WS) end. Slide gate in 36-inch corrugated metal pipe riser unit on the WS slope. Two corrugated metal cutoff walls. Concrete headwalls on both ends. (24-inch pipe [HLM 10.08] authorized under Automatic Board Order (ABO) issued as Permit No. 9558, 1974 - Duard Geis). [Additional Reference(s): DWR Levee Log, 1992. USACE Sacramento O&M Manual 140, May 1960, (HLM 10.08)]. FS Date: 5/31/2013 8:43:01 AM

Pipe and headwall on LS toe.

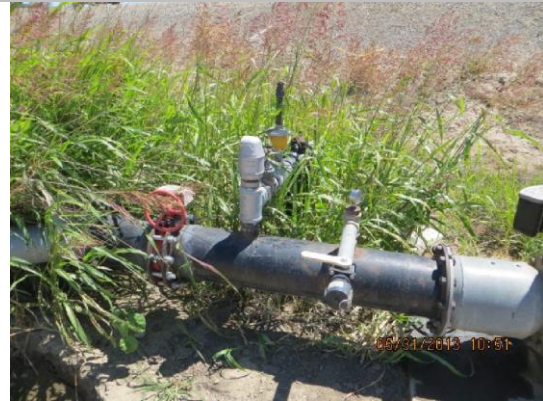
Photo 1 of 3 : UCIP_FA_2018_16205_27333.jpg

Pump with siphon breaker, vent and filter on LS toe.

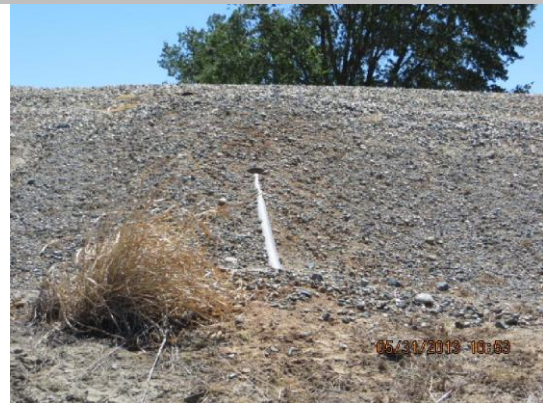
Photo 2 of 3 : UCIP_FA_2018_16205_27332.jpg

Pipe on LS slope.

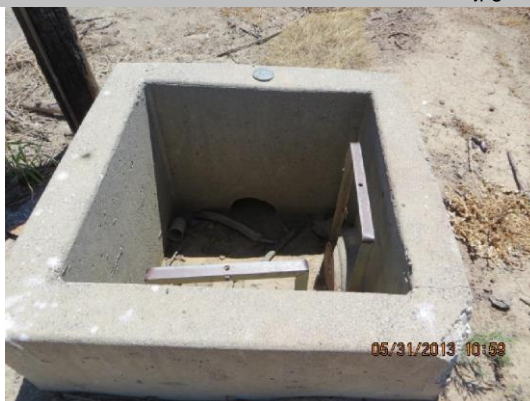
Photo 2 of 3 : UCIP_FA_2018_14561_23988.jpg

Item	DWR UCIP Field Study			39.607474 °	39.607474 °	
				-121.994410 °	-121.994410 °	
DWR ID	22923					
Comment Code						
Inspector Comment						
FS_ID:14561						
DS_ID:22923						
EP_NO: 9557						
Repair Type: Non-Urgent						
Crossing Status: Found						
UCIP Comments: This pipe appears abandoned and should be done so properly.						
FIELD_STRUCT_DESC: 1 of 2: 10-inch irrigation pipe of an unknown material through the levee, 3.7 feet below the crown. Pump on bank. Siphon breaker on the waterside (WS) berm. One corrugated metal cutoff wall. Concrete distribution box at the landside (LS) toe. (10-inch pipe authorized under Automatic Board Order (ABO) issued as Permit No. 9557, 1974 - Robert and Ruth Weis). [Additional Reference(s): DWR Levee Log, 1992. USACE Sacramento O&M Manual 140, May 1960, (HLM 10.56)].						
FS Date: 5/31/2013

Concrete distribution box at LS toe with outlet from pipe through levee.

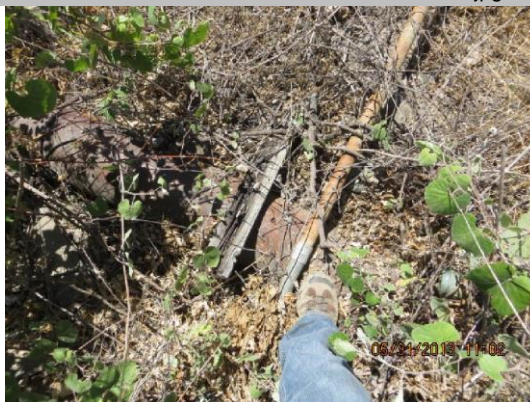
Photo 3 of 3 : UCIP_FA_2018_14561_23987.jpg

10-inch steel pipe and 1.5-inch electrical conduit on WS slope.

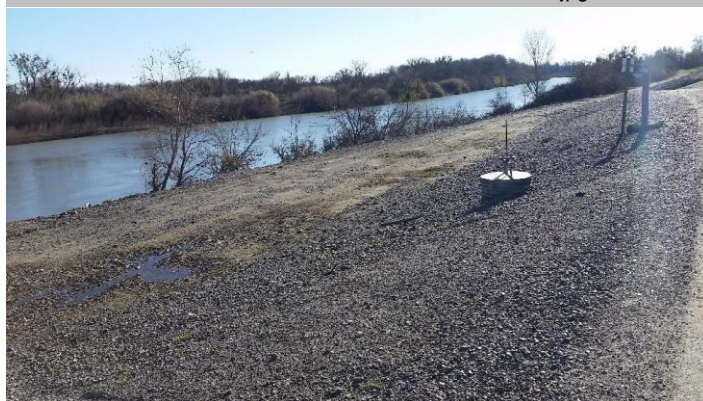
Photo 1 of 3 : UCIP_FA_2018_53340_76411.jpg

Comment Code						
Inspector Comment						
FS_ID:53340 DS_ID:22924 EP_NO: 9556 Repair Type: Urgent Crossing Status: Found UCIP Comments: 10/9/2018 Large rock at the bottom of CMP riser obstructs slide gate from completely closing. Pipe is rusted through at WS end. Recommend internal inspection to determine condition of pipe through levee, and to clean the inside of CMP riser for proper slide gate function. (O.Yakimov - DWR)12/21/2016 same as last inspection flap gate disabled in open position. Surface erosion observed on LS slope. Recommend repair on WS flap gate to be able to close flap gate. (O. Magana - DWR UCIP)05/31/2013 Flap gate dissabled in open position. Pipe rusted through at WS toe upstream of Flapgate. (W. Wylie - DWR UCIP) FIELD_STRUCT_DESC: 24-inch corrugated metal drainage pipe through levee, 15 feet below crown. Flap gate is located on the waterside (WS) end. Slide gate is inside a corrugated metal pipe (CMP) riser located on the WS slope. Two CM cutoff walls. Concrete headwall is located on LS and under outlet at the WS toe. (24-inch pipe [HLM 10.59] authorized under Automatic Board Order (ABO) issued as Permit No. 9556, 1974 - E. R & M. R. Cooper). [Additional Reference(s): DWR Levee Log, 1992. USACE Sacramento O&M Manual Unit 140, May 1960, (HLM 10.59)]. FS Date: 10/9/2018 4:05:00 PM

View of WS.

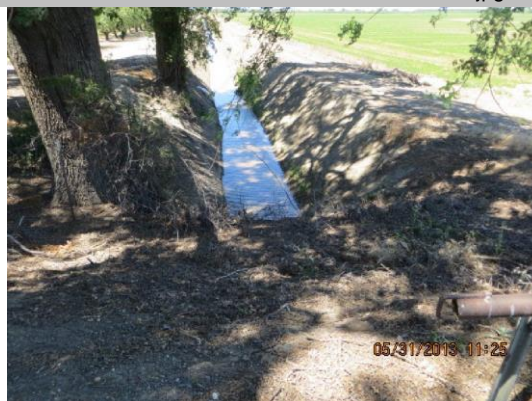
Photo 1 of 3 : UCIP_FA_2018_14565_24009.jpg

Comment Code					
Inspector Comment					
FS_ID:14565 DS_ID:22925 EP_NO: 9556 Repair Type: No Action Needed Crossing Status: Found UCIP Comments: FIELD_STRUCT_DESC: 48-inch corrugated metal drainage pipe through the levee, 11 feet below the crown. Flap gate on the waterside (WS) end. Concrete headwall on both ends. Slide gate in 60-inch diameter corrugated metal riser unit on the WS slope (48-inch pipe [HLM 11.17] authorized under Automatic Board Order (ABO) issued as Permit No. 9556, 1974 - Earl R. and Merrit R. Cooper). [Additional Reference(s): DWR Levee Log, 1992. USACE Sacramento O&M Manual 140, May 1960, (HLM 11.17)]. FS Date: 5/31/2013

Drainage ditch on LS toe.

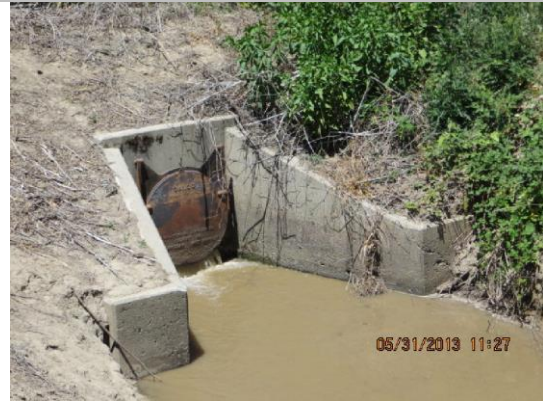
Photo 3 of 3 : UCIP_FA_2018_14565_24007.jpg

Comment Code					
Inspector Comment					
FS_ID:14565 DS_ID:22925 EP_NO: 9556 Repair Type: No Action Needed Crossing Status: Found UCIP Comments: FIELD_STRUCT_DESC: 48-inch corrugated metal drainage pipe through the levee, 11 feet below the crown. Flap gate on the waterside (WS) end. Concrete headwall on both ends. Slide gate in 60-inch diameter corrugated metal riser unit on the WS slope (48-inch pipe [HLM 11.17] authorized under Automatic Board Order (ABO) issued as Permit No. 9556, 1974 - Earl R. and Merrit R. Cooper). [Additional Reference(s): DWR Levee Log, 1992. USACE Sacramento O&M Manual 140, May 1960, (HLM 11.17)]. FS Date: 5/31/2013

Flap gate and concrete headwall on WS toe.

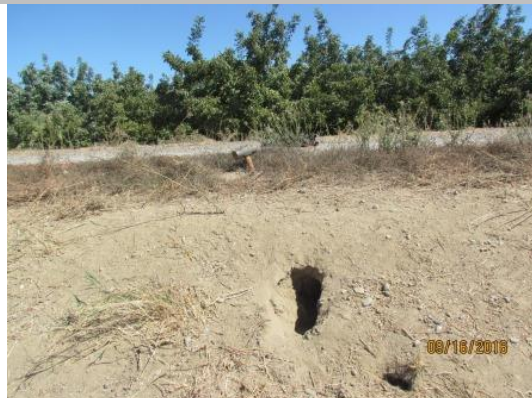
Photo 1 of 2 : FA_2018_LD0001G_432_79_20180905_00032.jpg

LM Start	11.66	Rating **	M	Issue No.	79
LM End	11.66	Issue Type +	Ma	Location *	LS
Category	Earthen Levee			GPS Latitude/Longitude	
				Start	End
Item	Animal Control			39.624112 °	39.624112 °
				-121.999933 °	-121.999933 °
DWR ID	DWR_LD0001G_01_f _ 2016_79				
Comment Code					
A3 : No rodents visible, but rodent burrows visible; need to backfill and compact or grout burrows.					
Inspector Comment					
Rodent holes on the landside slope and crown.

View of the rodent holes along the landside slope with large hammer sitting in the hole.

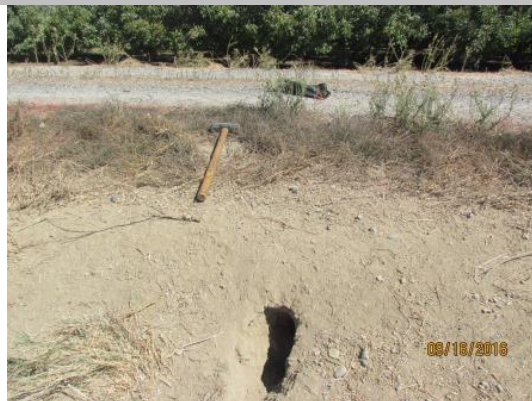
Photo 2 of 2 : FA_2018_LD0001G_432_79_20180905_00033.jpg

Another view of the rodent holes along the landside slope with a large hammer sitting next to the hole.

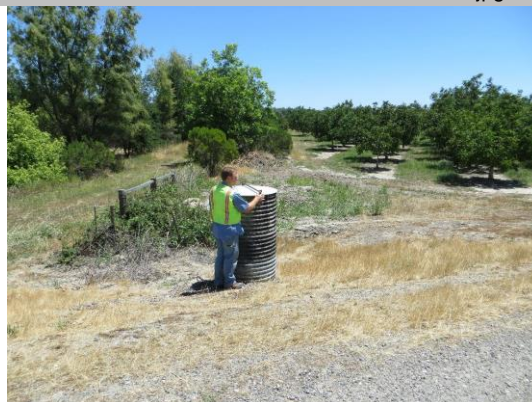
Photo 2 of 3 : UCIP_FA_2018_14567_24016.jpg

Comment Code					
Inspector Comment					
FS_ID:14567 DS_ID:22927 EP_NO: 9554 Repair Type: Non-Urgent Crossing Status: Found UCIP Comments: Erosion and sloughing on LS slope possibly due to rodent activity in area. FIELD_STRUCT_DESC: 24-inch corrugated metal drainage pipe through the levee, 11 feet below the crown. Slide gate in 36-inch corrugated metal riser unit on the waterside (WS) slope. 48-inch concrete standpipe on the landside (LS) toe. Two corrugated metal cutoff walls. (24-inch pipe [HLM 11.93] authorized under Automatic Board Order (ABO) issued as Permit No. 9554, 1974 - Thomas H. Reed). [Additional Reference(s): DWR Levee Log, 1992. USACE Sacramento O&M Manual 140, May 1960, (HLM 11.93)]. FS Date: 5/31/2013

Slide gate in CMP riser on WS toe.

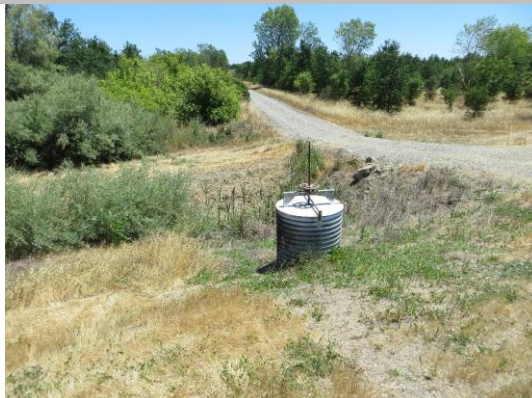
Photo 1 of 3 : UCIP_FA_2018_14569_24026.jpg

Comment Code						
Inspector Comment						
FS_ID:14569						
DS_ID:22928						
EP_NO: 9554						
Repair Type: Non-Urgent						
Crossing Status: Found						
UCIP Comments: Flap gate heavily corroded. Good candidate for video inspection. Vegetation interfering with inlet.						
FIELD_STRUCT_DESC: 24-inch corrugated metal drainage pipe through the levee, 7 feet below the crown. Flap gate on the waterside (WS) end. Slide gate in 36-inch corrugated metal pipe riser unit on the WS slope. Concrete headwalls on both ends. Two corrugated metal cutoff walls. (24-inch pipe [12.04] authorized under Automatic Board Order (ABO) issued as Permit No. 9554, 1974 - Thomas H. Reed). [Additional Reference(s): DWR Levee Log, 1992. USACE Sacramento O&M Manual 140, May 1960, (HLM 12.04)].						
FS Date: 5/31/2013

Slidegate in 36-inch CMP riser on WS slope.

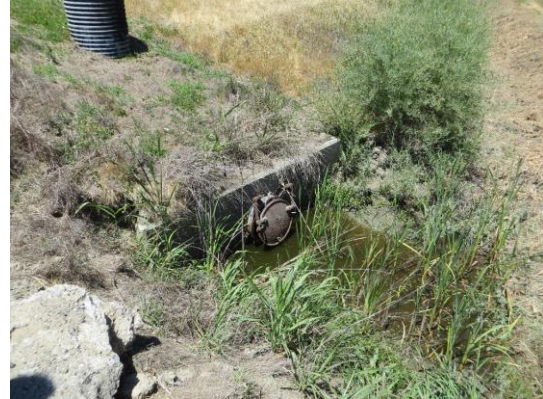
Photo 3 of 3 : UCIP_FA_2018_14569_24024.jpg

Comment Code					
Inspector Comment					
FS_ID:14569 DS_ID:22928 EP_NO: 9554 Repair Type: Non-Urgent Crossing Status: Found UCIP Comments: Flap gate heavily corroded. Good candidate for video inspection. Vegetation interfering with inlet. FIELD_STRUCT_DESC: 24-inch corrugated metal drainage pipe through the levee, 7 feet below the crown. Flap gate on the waterside (WS) end. Slide gate in 36-inch corrugated metal pipe riser unit on the WS slope. Concrete headwalls on both ends. Two corrugated metal cutoff walls. (24-inch pipe [12.04] authorized under Automatic Board Order (ABO) issued as Permit No. 9554, 1974 - Thomas H. Reed). [Additional Reference(s): DWR Levee Log, 1992. USACE Sacramento O&M Manual 140, May 1960, (HLM 12.04)]. FS Date: 5/31/2013

Headwall and flapgate on WS toe.

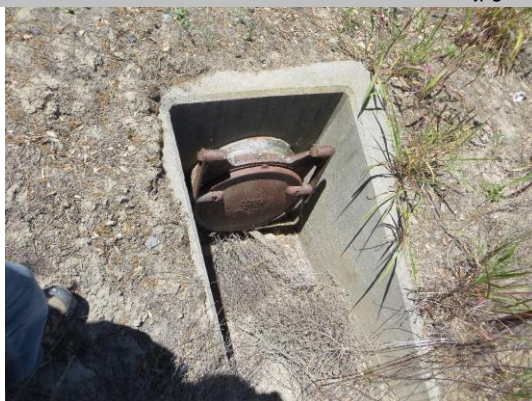
Photo 1 of 3 : UCIP_FA_2018_14570_24029.jpg

LM Start	12.13	Rating **	A/W	Issue No.	423
LM End	12.13	Issue Type +	Ma	Location *	
Category	Supplemental			GPS Latitude/Longitude	
				Start	End
Item	DWR UCIP LMA Responsibility			39.630451 °	39.630451 °
				-122.002737 °	-122.002737 °
DWR ID	22929				
Comment Code					
Inspector Comment					
FS_ID:14570 DS_ID:22929 EP_NO: 9554 Repair Type: No Action Needed Crossing Status: Found UCIP Comments: FIELD_STRUCT_DESC: 24-inch corrugated metal drainage pipe through the levee, 7 feet below the crown. Flap gate on the waterside (WS) end. Slide gate in 36-inch corrugated metal riser unit on the WS slope. Concrete U-shaped headwalls on both ends. (24-inch pipe [HLM 12.29] authorized under Automatic Board Order (ABO) issued as Permit No. 9554, 1974 - Thomas H. Reed). [Additional Reference(s): DWR Levee Log, 1992. USACE Sacramento O&M Manual 140, May 1960, (HLM 12.29)]. FS Date: 5/31/2013

Flapgate and U-shaped concrete headwall on WS toe.

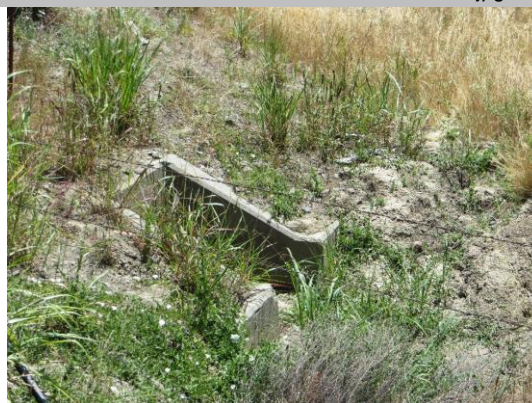
Photo 3 of 3 : UCIP_FA_2018_14570_24027.jpg

Item	DWR UCIP LMA Responsibility			39.630451 °		39.630451 °
				-122.002737 °		-122.002737 °
DWR ID	22929					
Comment Code						
Inspector Comment						
FS_ID:14570 DS_ID:22929 EP_NO: 9554 Repair Type: No Action Needed Crossing Status: Found UCIP Comments: FIELD_STRUCT_DESC: 24-inch corrugated metal drainage pipe through the levee, 7 feet below the crown. Flap gate on the waterside (WS) end. Slide gate in 36-inch corrugated metal riser unit on the WS slope. Concrete U-shaped headwalls on both ends. (24-inch pipe [HLM 12.29] authorized under Automatic Board Order (ABO) issued as Permit No. 9554, 1974 - Thomas H. Reed). [Additional Reference(s): DWR Levee Log, 1992. USACE Sacramento O&M Manual 140, May 1960, (HLM 12.29)]. FS Date: 5/31/2013

U-shaped concrete headwall on LS toe.
